Barn, North Farm, Shropham Road, Great Hockham, Norfolk

A Report by Dr Adam Longcroft BA (Hons), MA, Phd, FHEA
Senior Lecturer in Local and Regional Studies, University of East Anglia

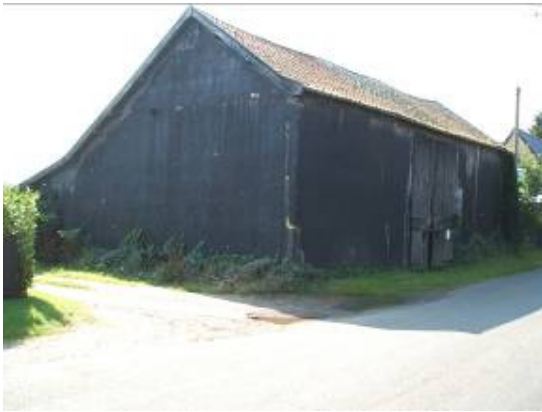
Photograph 1

The west front of the barn, North Farm, Great Hockham. The gentle pitch of the pantiled roof, the black bitumen render of the side walls and gable, and the main threshing doors are all clearly visible. Notice, also, the rare lean-to at the rear. The barn is located directly on the roadside (Shropham Road). Although there were clay lump buildings on the site, and others in the village centre, this is the only securely identified example of a shuttered-clay building in Great Hockham. (Photograph taken by the author)

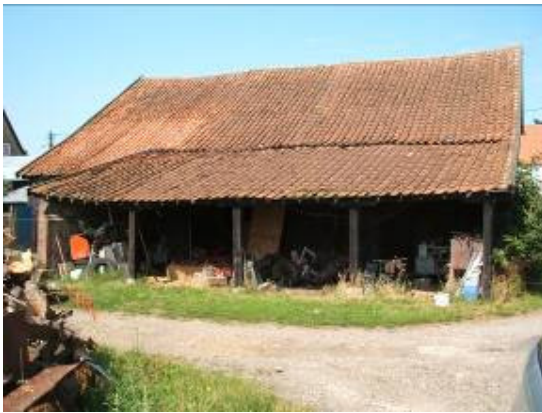
Photograph 2

The east view of the barn, North Farm, Great Hockham. The four-bay cart shed is probably a nineteenth-century addition to the barn proper. The barn appears to be of eighteenth century date – a construction date in the second half of the century being most likely.

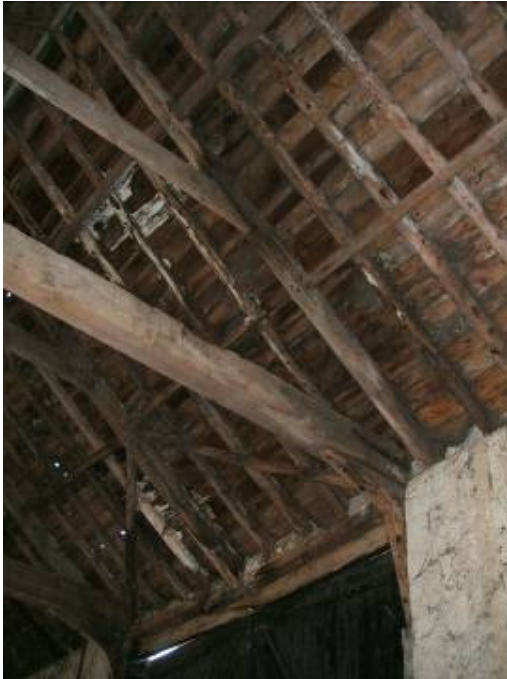
Photograph 3

The interior of the barn. The roof is of butt-purlin type and the use of heavily diminished (chamfered) tenons is a good indicator of relatively late construction – in this case probably in the second half of the eighteenth century. (Photograph taken by the author). The straight wind braces can be seen clearly, along with the collar and the elbowed braces employed to support the tie beams. These are nailed into position (not pegged) and are probably nineteenth-century additions. (Photograph by the author).

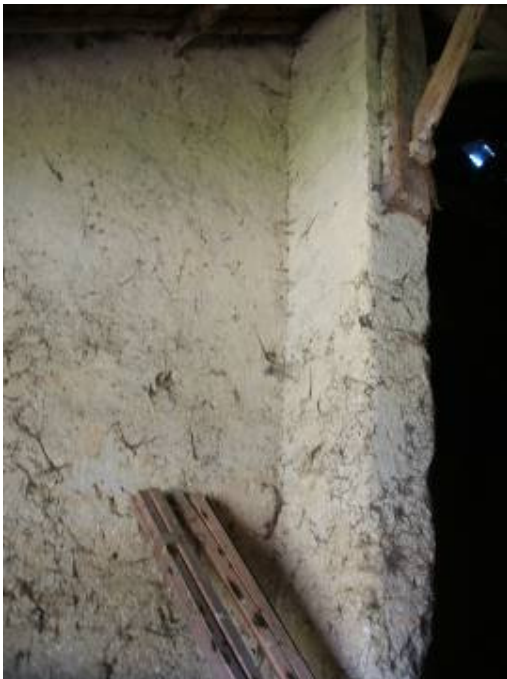
Photograph 4

The interior of the barn, showing the shuttered clay construction of the walls. The distinctive 'block' pattern associated with clay lump is entirely absent. Instead, one can discern the individual 'shifts' in which the shuttered clay walls were raised. The use of shuttering is indicated by the verticality of the walls – there is none of the typical 'tapering from bottom to top' which one would expect to see in a 'cob' wall. (Photograph by the author).
